Dyson V6 Motorhead Brush Bar Replacement

Brush bars have a history of failing, issues of them not rotating as well as wearing out.

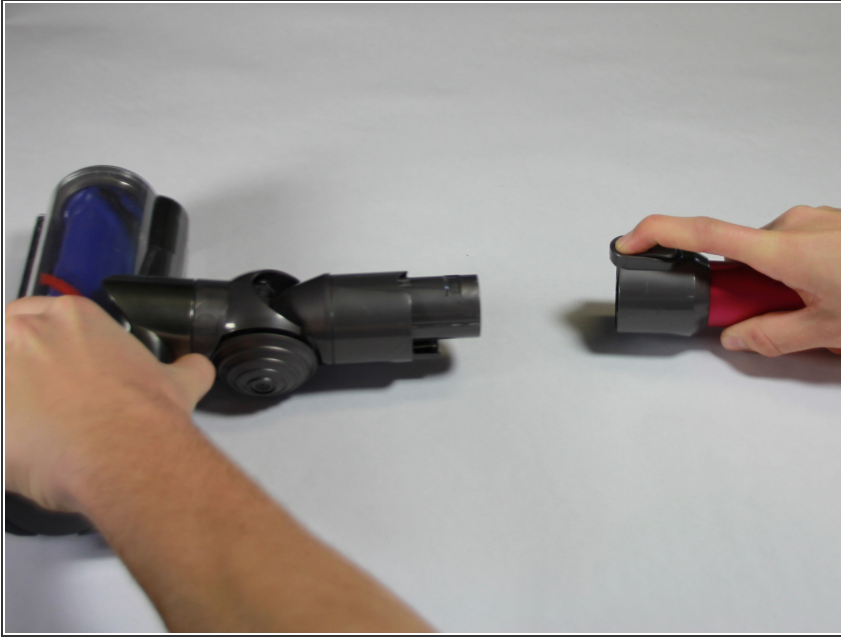
Step 1 — Brush Bar

- Press the button to disconnect the vacuum head from the connecting pole.

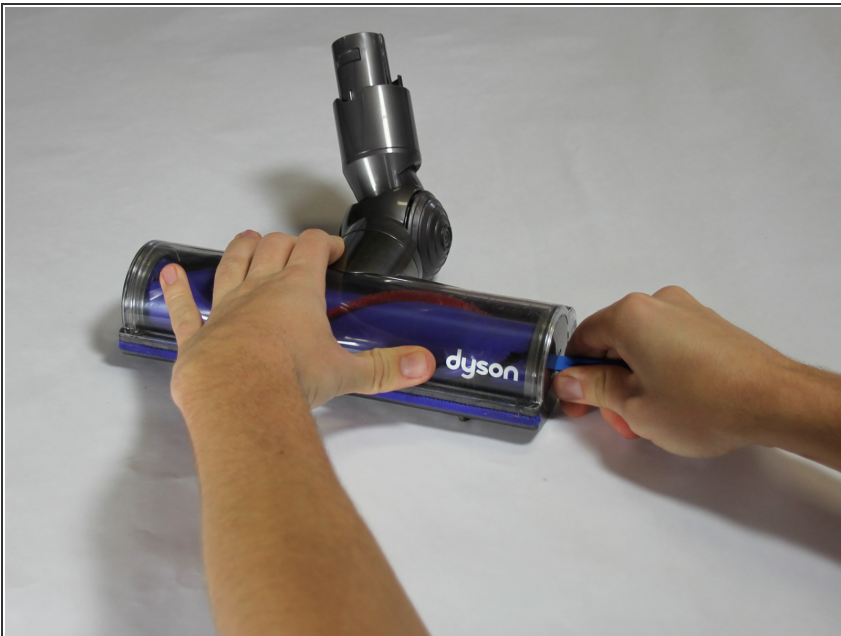
Step 2

- Turn the end cap counterclockwise using the iFixit Opening Tool.
- ⓘ If you do not have an iFixit Opening Tool, a quarter may be used instead.

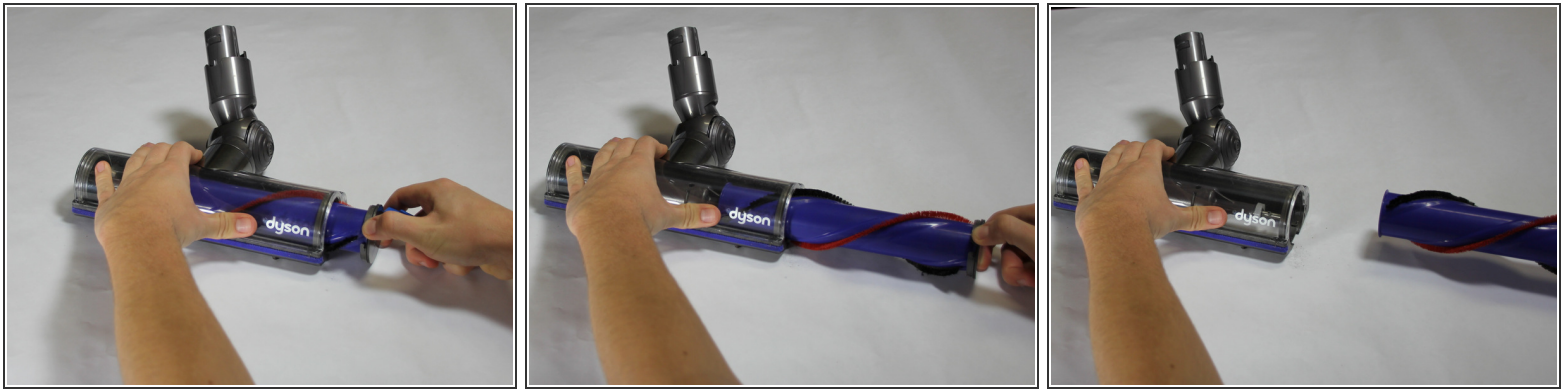
Step 3

- Pull the brush bar out of the housing.
